CROSSFEED

Battery Safety

Lithium Batteries Are Explosive!

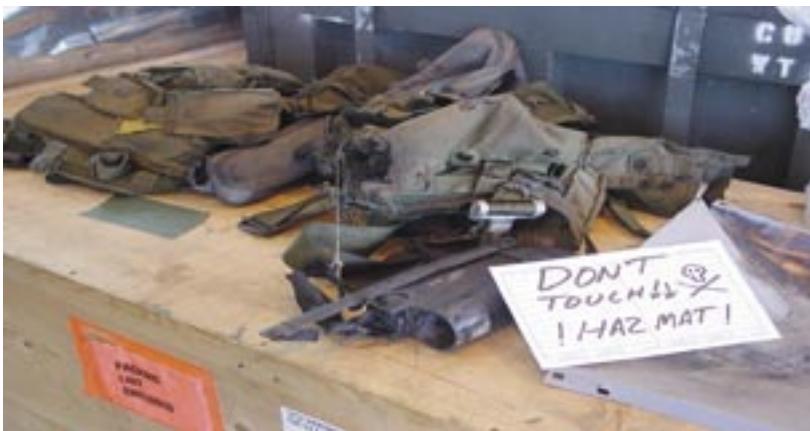
Are you the command battery-safety program manager? If so, did you know that you are responsible for ALL batteries used in your command? An alarming trend has developed in the battery-safety program that was discovered during recent safety surveys. The program managers that I surveyed were unaware that they are responsible for lithium batteries used in the ALSS and COMSEC workcenters. All program managers understood the responsibility for aircraft installed batteries with respect to replacement, training, and emergencies; but they had little idea about the lithium batteries used in the PRC-149 survival radio/COMSEC equipment and the explosive danger they pose (see attached photo).

New and used lithium batteries will be stored in their original shipping containers and must be individually sealed in a plastic bag or wrapped in electrical insulating material while being stored in a cool, ventilated shelter.

Isolate the storage area from other hazardous and consumable material and use only for storage of used/unused lithium batteries.

Do not pierce, crush, burn, drop, cannibalize, dismantle, modify, or otherwise carelessly handle, nor short circuit, charge or reuse.

Effective and prompt disposal is required; do not store more than 30 pounds or for longer than 30 days.
